We visited the bridleways on 19 June 2013 starting at the Northern end of 415/56/1. We walked down to the junction with 415/41 then took 415/41 to return northwards to the road. We did not survey the leg 415/56/2 down to Trebudannon Farm.

**Walk through 415/56/1**

## Walk through 415/41/1

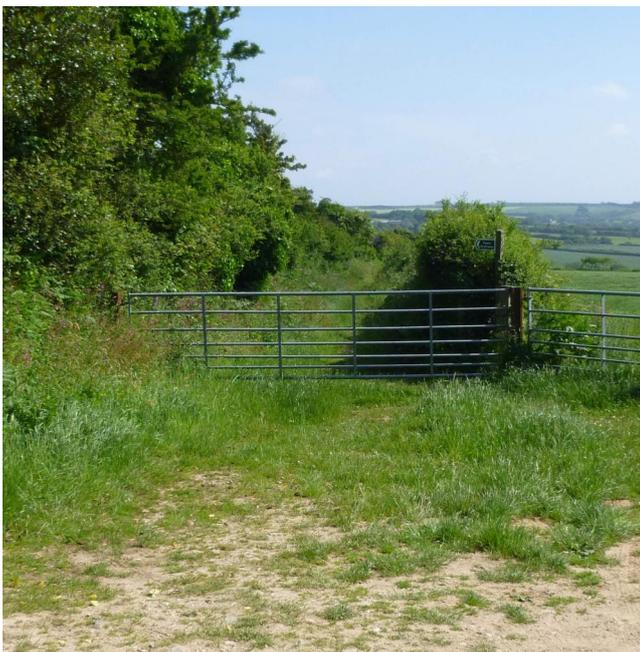
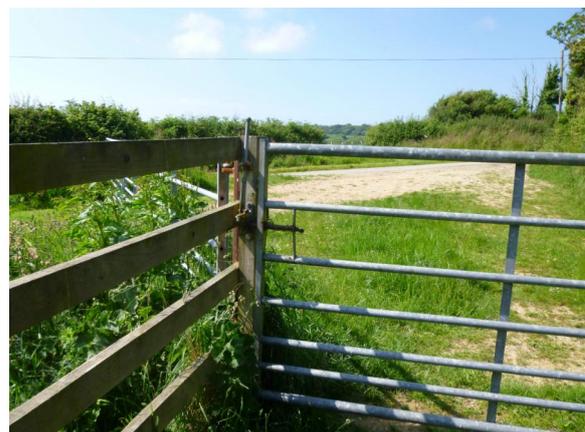
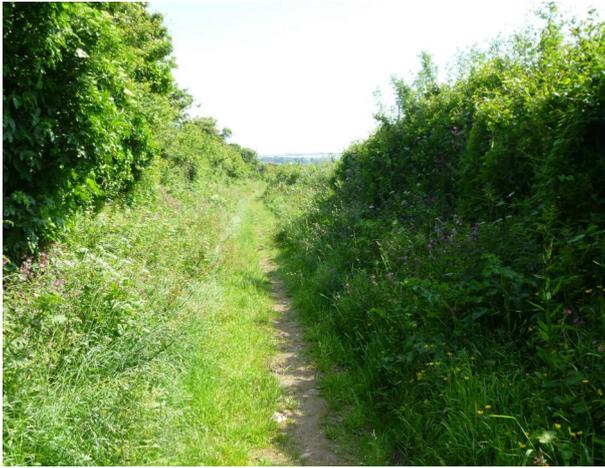
**Gate ID: 415/107      OS Grid Ref: SW893628**

The first gate is set back from the road and with a bridleway sign by the gate.

The gate is extremely large but does swing easily. The handle/catch operates OK. But it is of a design that is impossible to use without having one hand on the gate to open it whilst the other is on the handle that is attached to the post. More or less impossible on horseback and very difficult if dismounted whilst holding your horse.

- Overall the bridleway segment is usable. Gates are usable but difficult.
- There is no stock in the fields so all the gates are an unnecessary obstruction to use.
- In any case the first gate is not necessary for stock and should be removed.
- The field edge path is overgrown and uneven and unusable, users have to walk/ride along the edge of the path.
- Path broadly follows definitive line
- Pedestrian bridge onto the next segment is not usable without climbing and only for the agile.

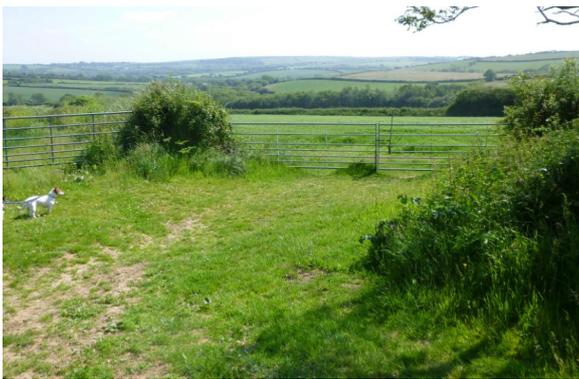
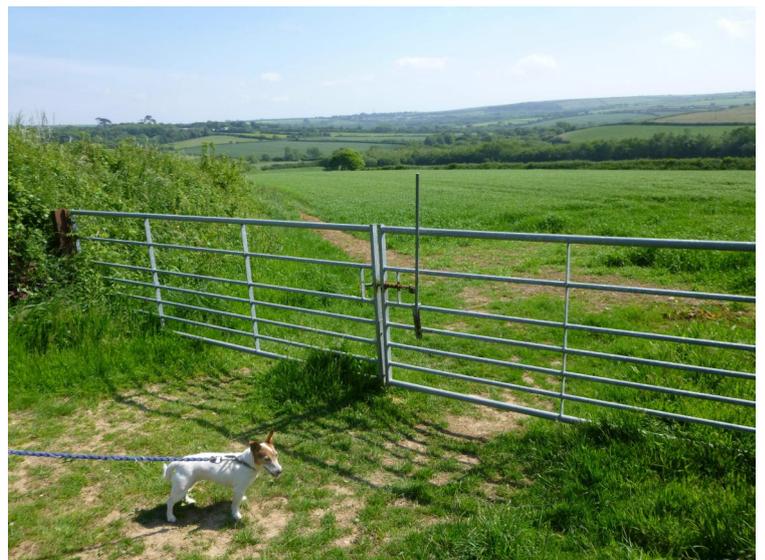
Then it zigzags to the right to a large double gate one side of which opens.

It has a horse handle and operates fine and well greased. Probably a little awkward from horse, but OK.

This gate is not recorded on CC GIS

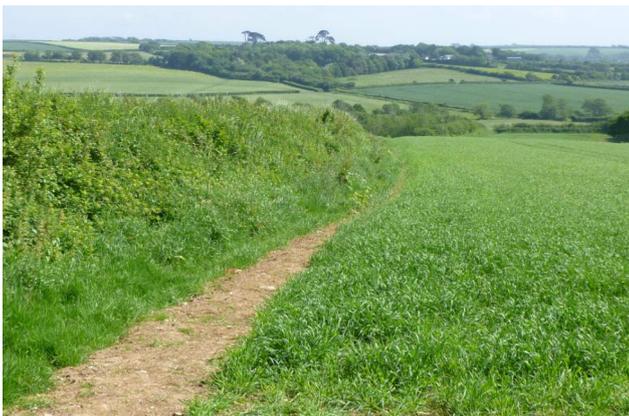
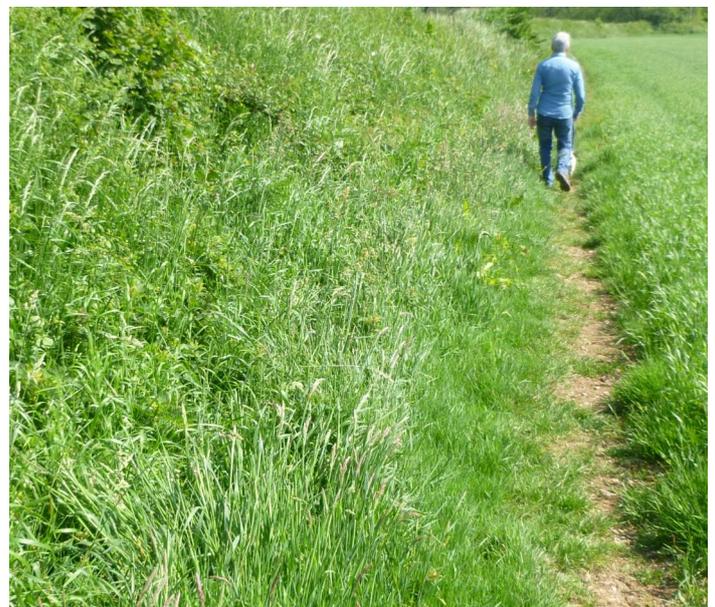
The bridleway continues down the field margin

The field margin where the path should run is overgrown and uneven. The only usable path is alongside the crop.

There have been great problems on this section of the path in the past when crops are planted with the field margin being disturbed and never levelled. The field margin wants properly restoring as bridleway

There will again be issues when crops are planted and also if rabbit netting is put up.

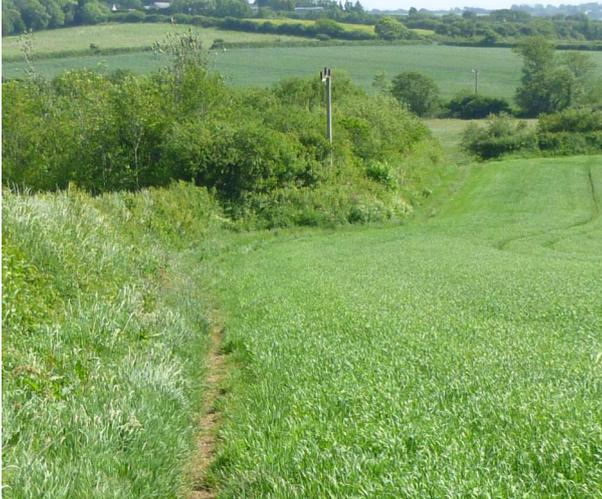
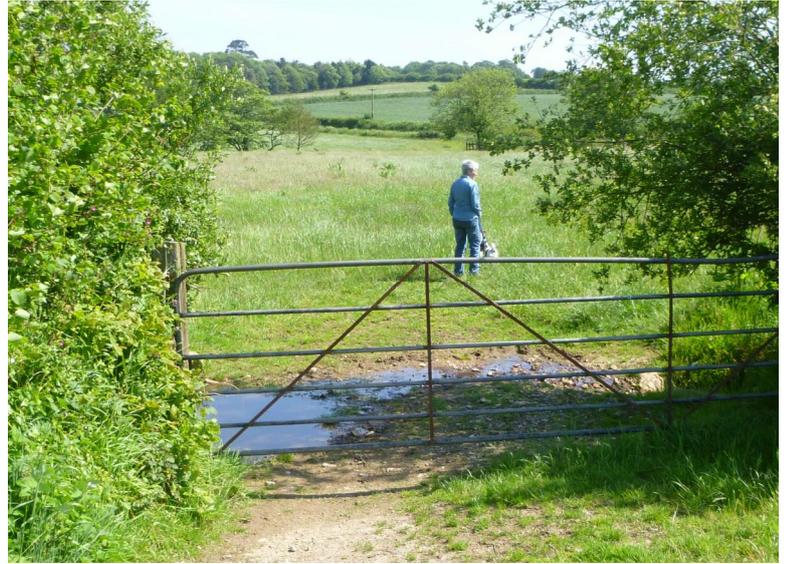
Gate ID: 415/106

Lower end of this section with gate (right) at bottom of the field. The gate is useable but very awkward - again requiring two hands because release handle is on post.

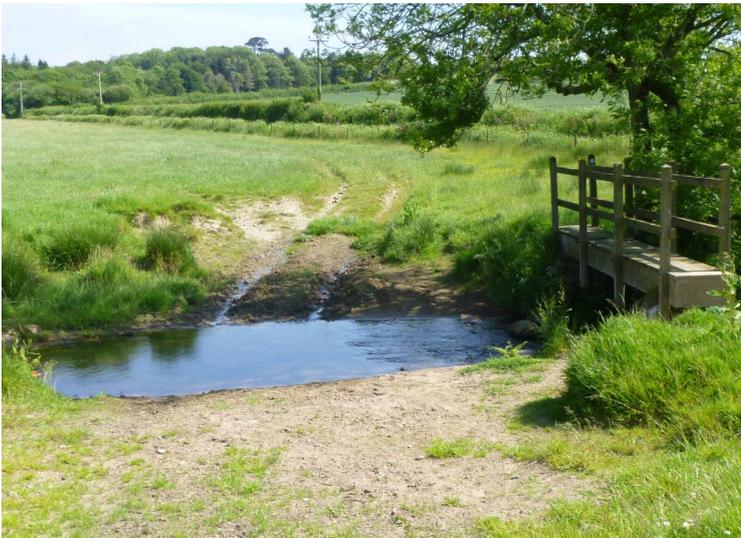
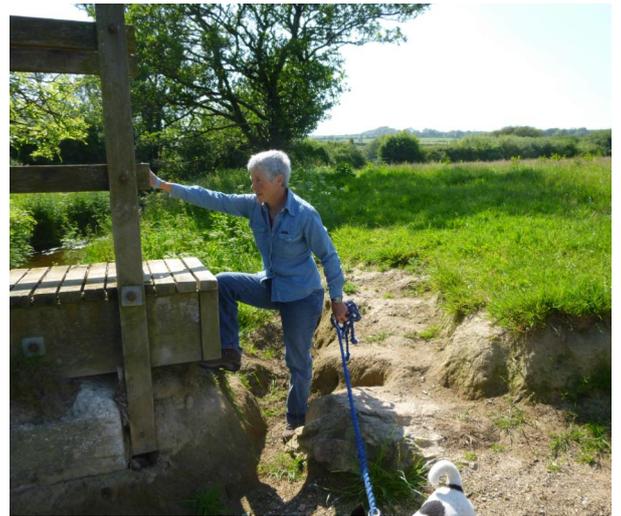
After crossing this field (path not defined) you reach a ford and a pedestrian bridge to reach leg 415/56/2

Horses use the ford but pedestrians have to climb three foot up from eroded ground -only for the agile!

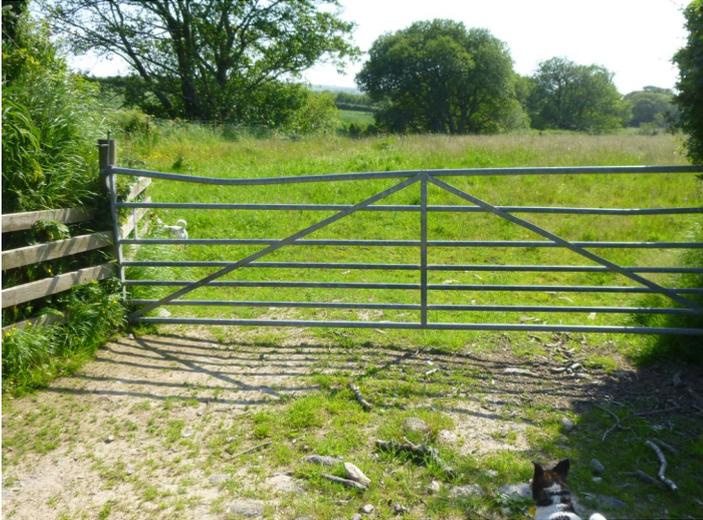
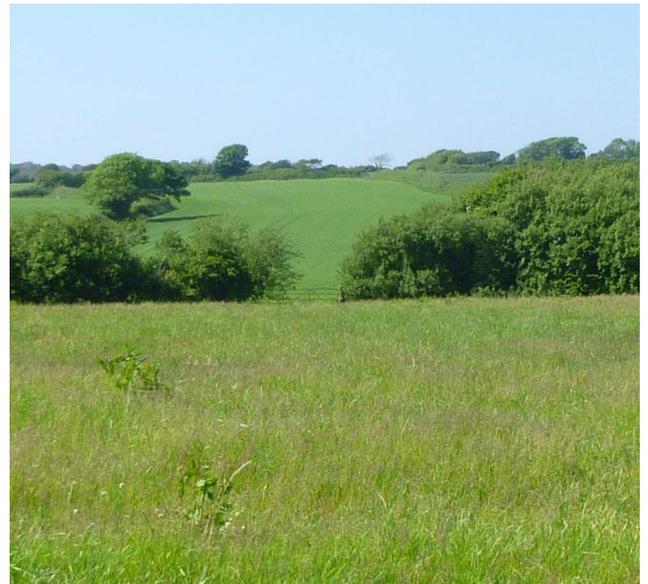
**Gate ID:** 415/214      **OS Grid Ref:** SW893621

On reaching the gate we found it fitted with a bridleway handle with "hunting" type latch. It was OK to use.

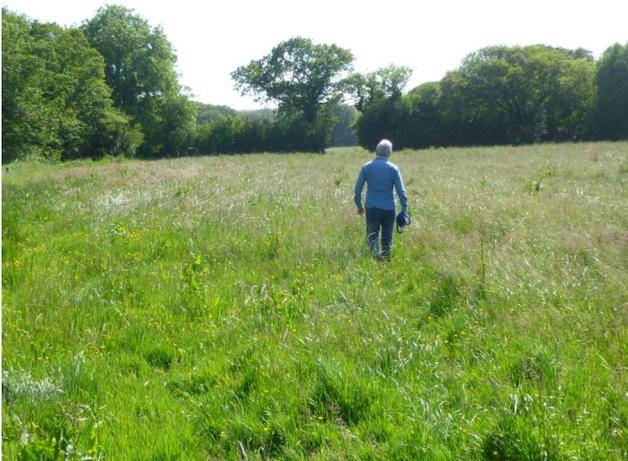
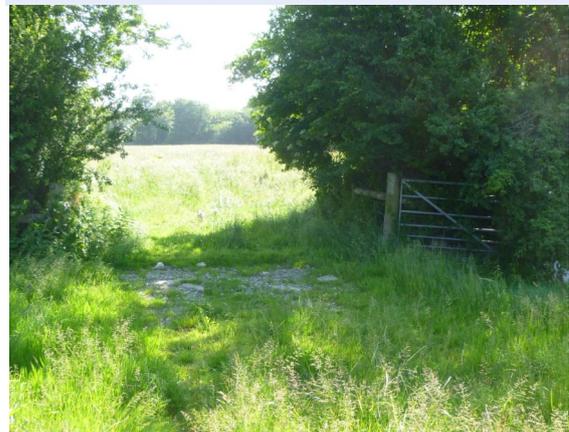
**Gate ID:** 415/215      **OS Grid Ref:** SW891620

On reaching the gap we found an open gate grown in, so it was impossible to assess its servicability

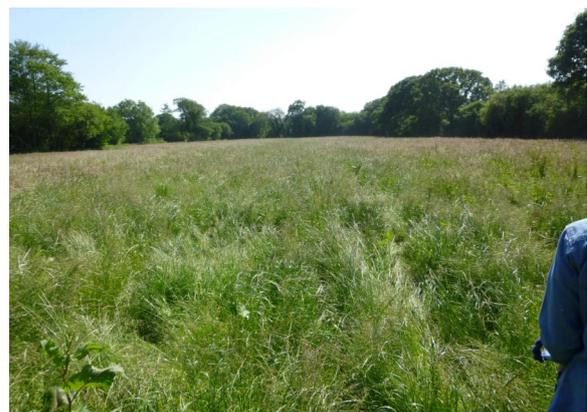
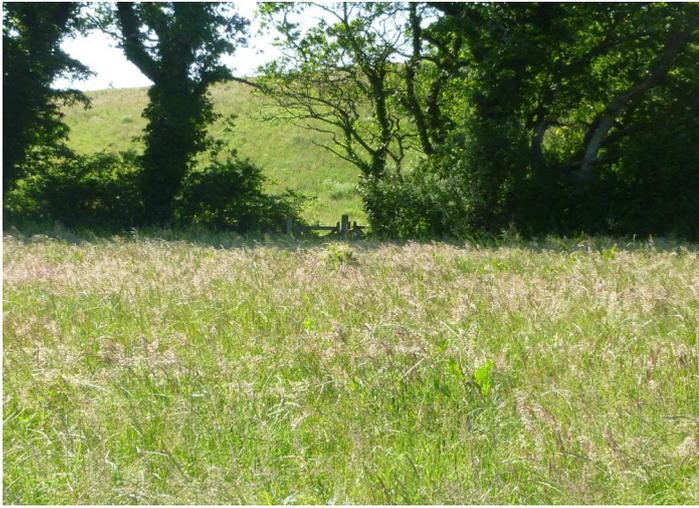
On going through the gate we were faced with this hayfield with no discernable path.

We ploughed on knowing that the path should veer right to a bridge. More by luck than judgement we saw a “structure” to the right but barely visible because it was in a dip.

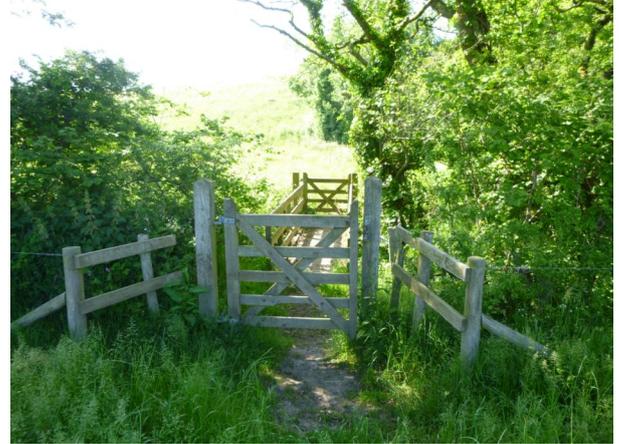
**Gate ID: 415/208 & 209 OS Grid Ref: SW890619**

We consider this gated bridge to be an illegal obstruction as the bridleway gates and gap are only 4 foot wide at best, as is the bridge itself. HA S145 requires a 5 foot minimum width.

This structure is relatively new so it is puzzling how this has been authorised on a bridleway.

Notwithstanding the narrow width, the first gate does just about have room either side to manoeuvre a horse.

The unnecessary second gate is directly on the bridge itself and is unsafe for use by horse owing to the confined space.

Also the sides of the bridge (notwithstanding narrow width) have no protecting bottom kick board, making it unsafe especially with the confined space.

On grounds of safety these gates want to be removed immediately.

In any case two gates are not required.

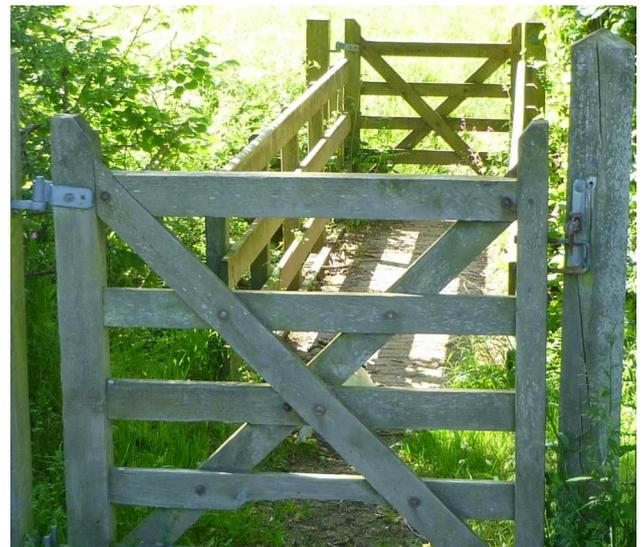
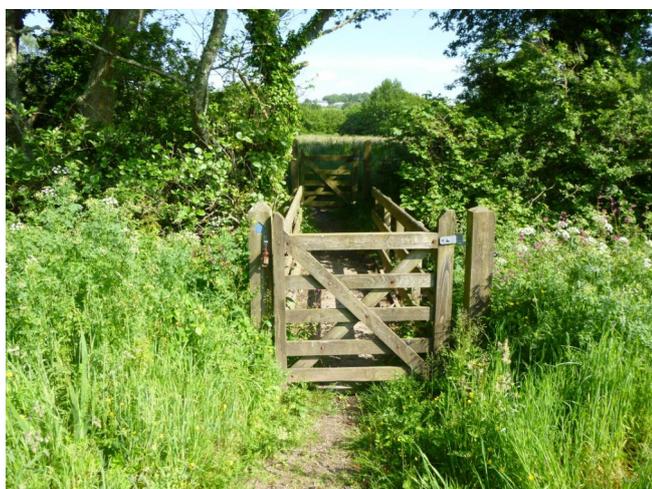
Below is picture looking back – how can a rider shut that gate behind him?

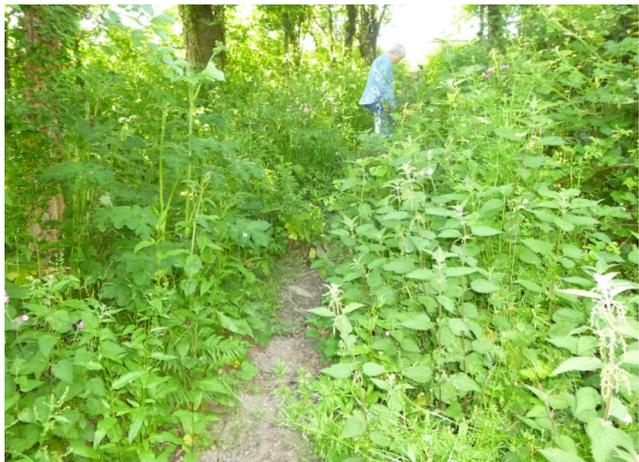
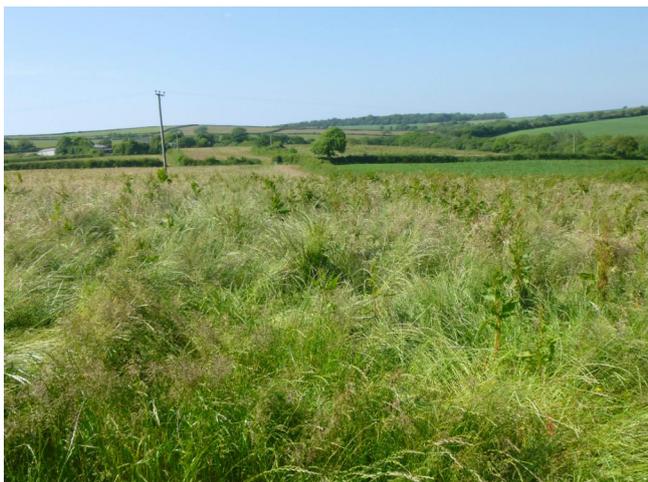
On going over the bridge there is a short section of field before a short steep section of path up through a small copse. You then come out into a field but the route of the bridleway is not at all clear. See RH pic.

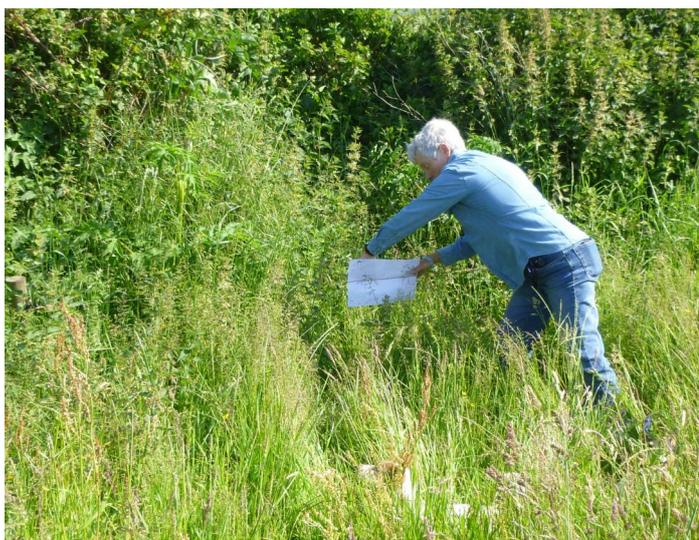
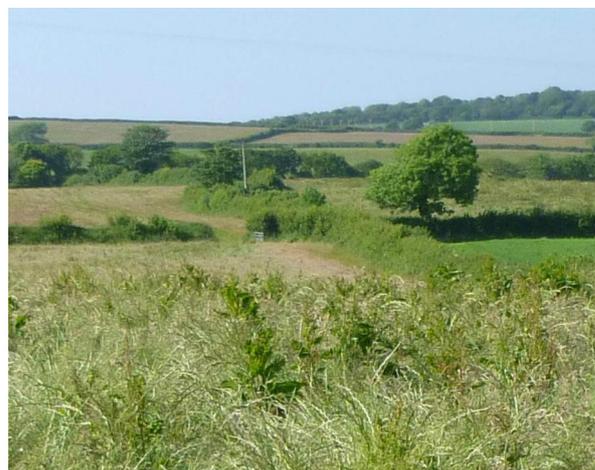
**Gate ID:** 415/209

We headed forward to see a gate gap in the distant hedge we headed for this. From the map and looking at the hedge it looked as if the BW should go through the hedge next to the field boundary – but was blocked and overgrown and with electric fence wire across.

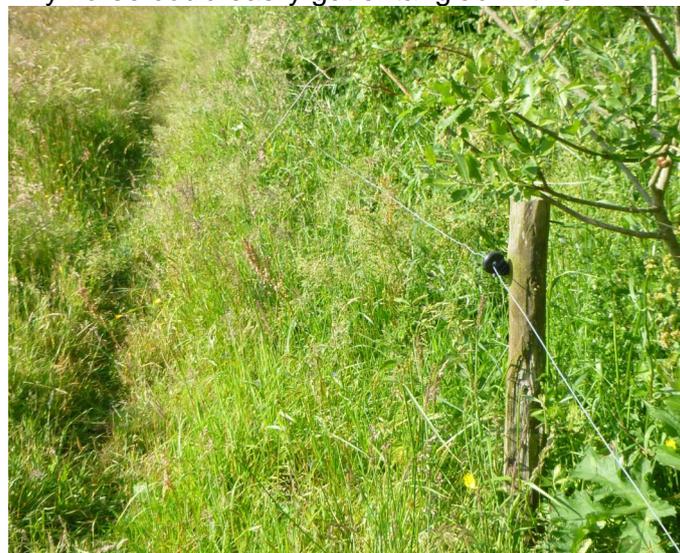
We then continued down the RH edge of the field and found a disused electric fence wire mostly hidden/buried all along the edge of the path.

Any horse could easily get entangled in this.

Wire buried in the grass right next to the path!

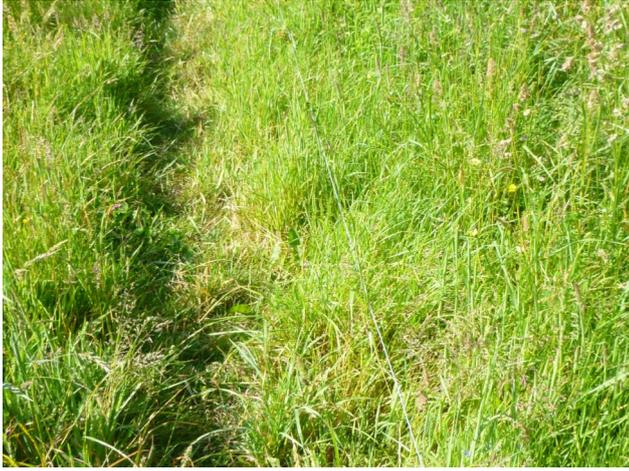
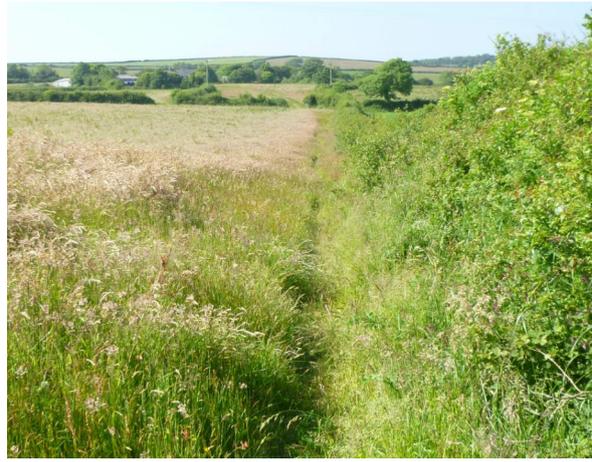
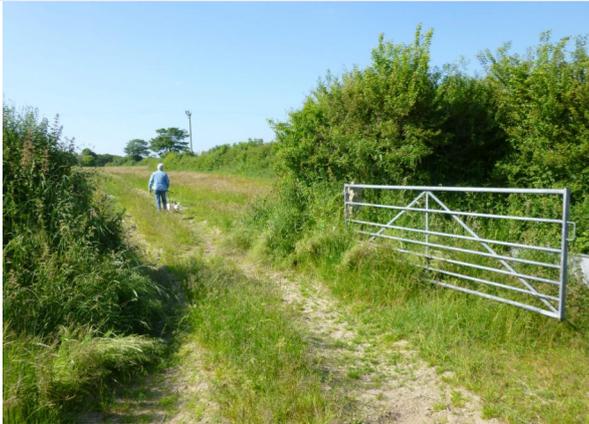
Gate ID: 415/210

On reaching the end of this field another gate (open and we did not test it) lead to the last field before reaching a short farm lane to the road.

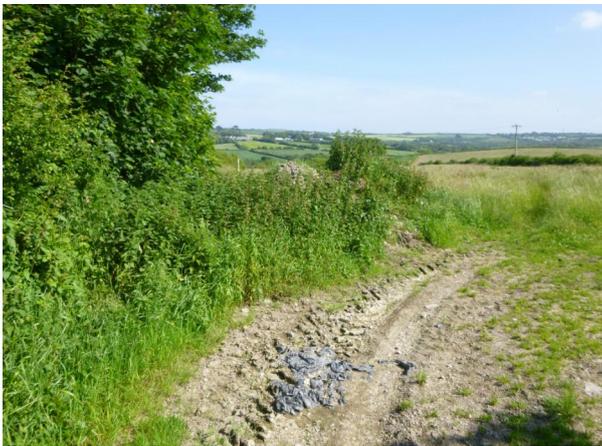
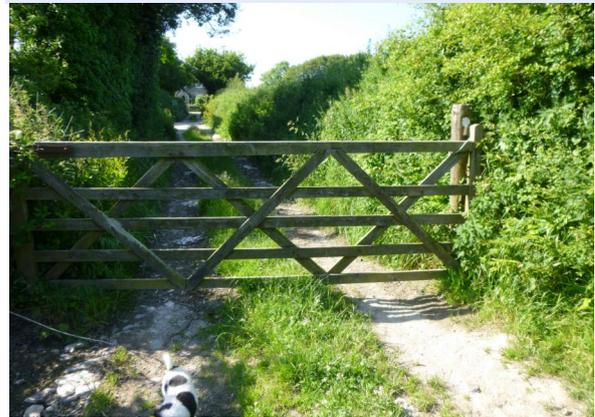
Gate ID: 415/212

However the definitive route of the bridleway just inside the first gate (from the road) is blocked by a large heap of soil and rubbish, forcing users to go around to the right. Picture left below.

Picture right below shows final gate looking towards road with rope fastener.
